MCR-68-119 Copy No.

STERILIZABLE LIQUID PROPULSION SYSTEM

FINAL REPORT (PART II)

MARTIN MARIETTA CORPORATION

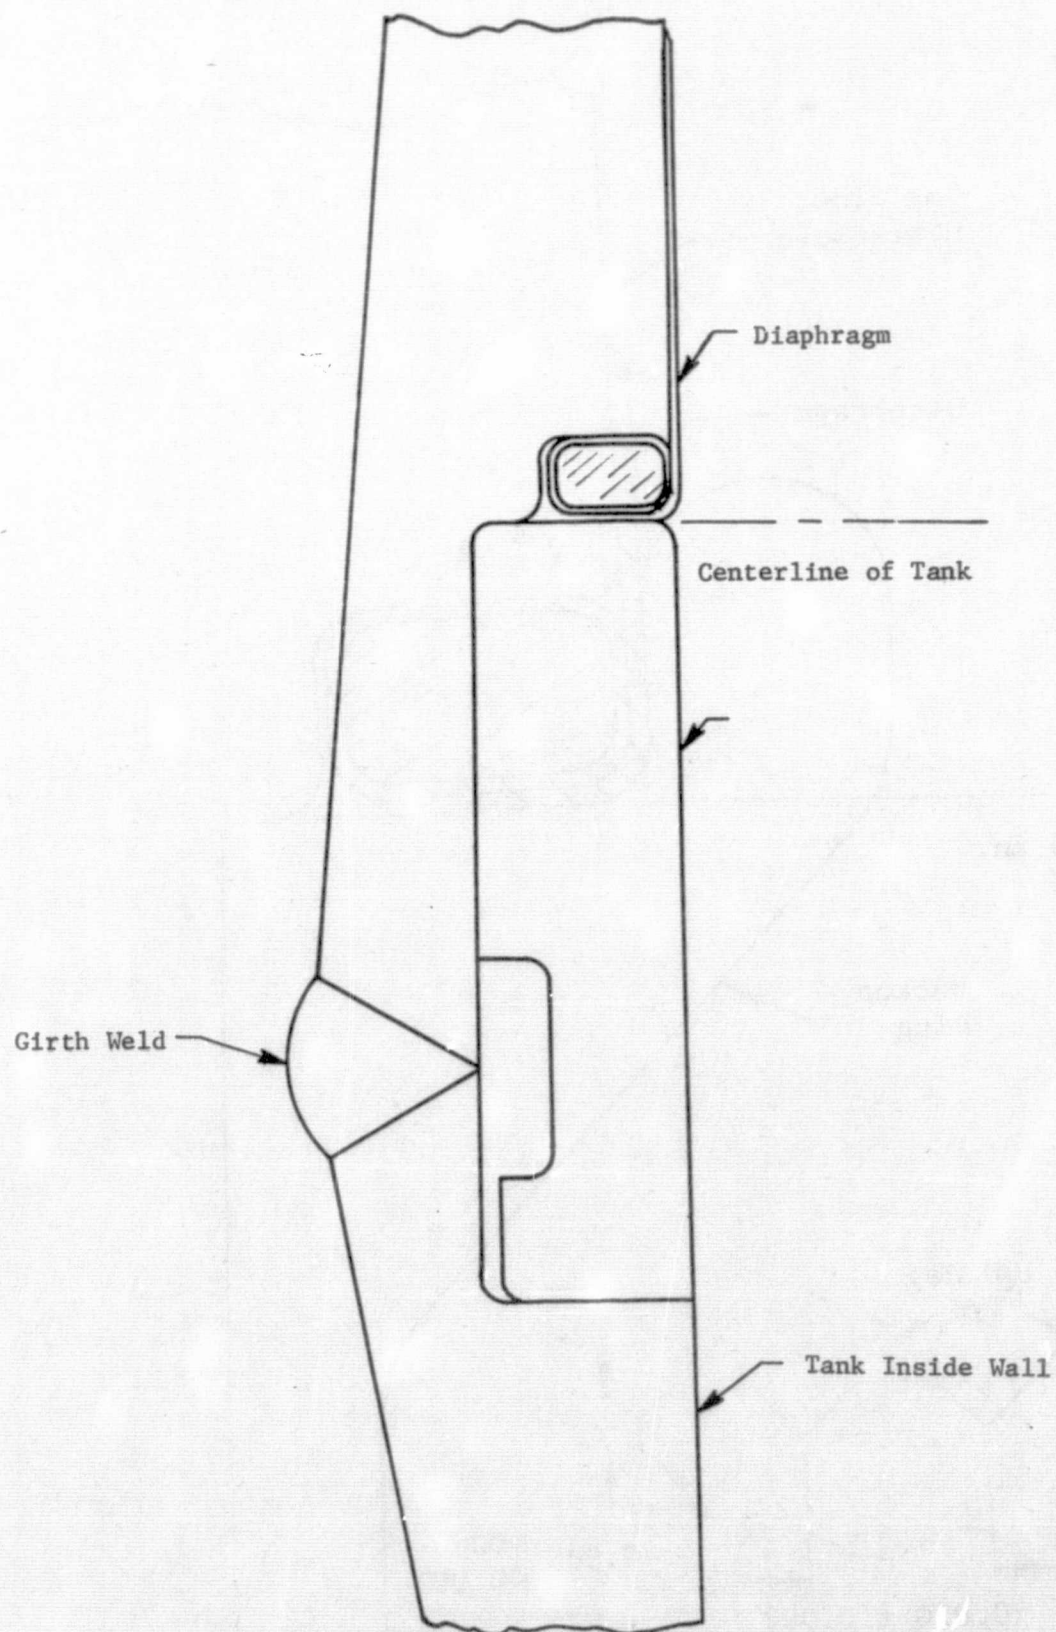
Fig. V-14 Oxidizer Tank Diaphragm Retainer Redesigned

The resulting design configuration to the oxidizer tank is shown in Fig. V-14. It provides for a centerline installation of the diaphragm. In this way, with proper sizing of tank and diaphragm, a line-to-line contact can be made between the diaphragm and the tank wall in either the fully loaded or the fully expelled position.

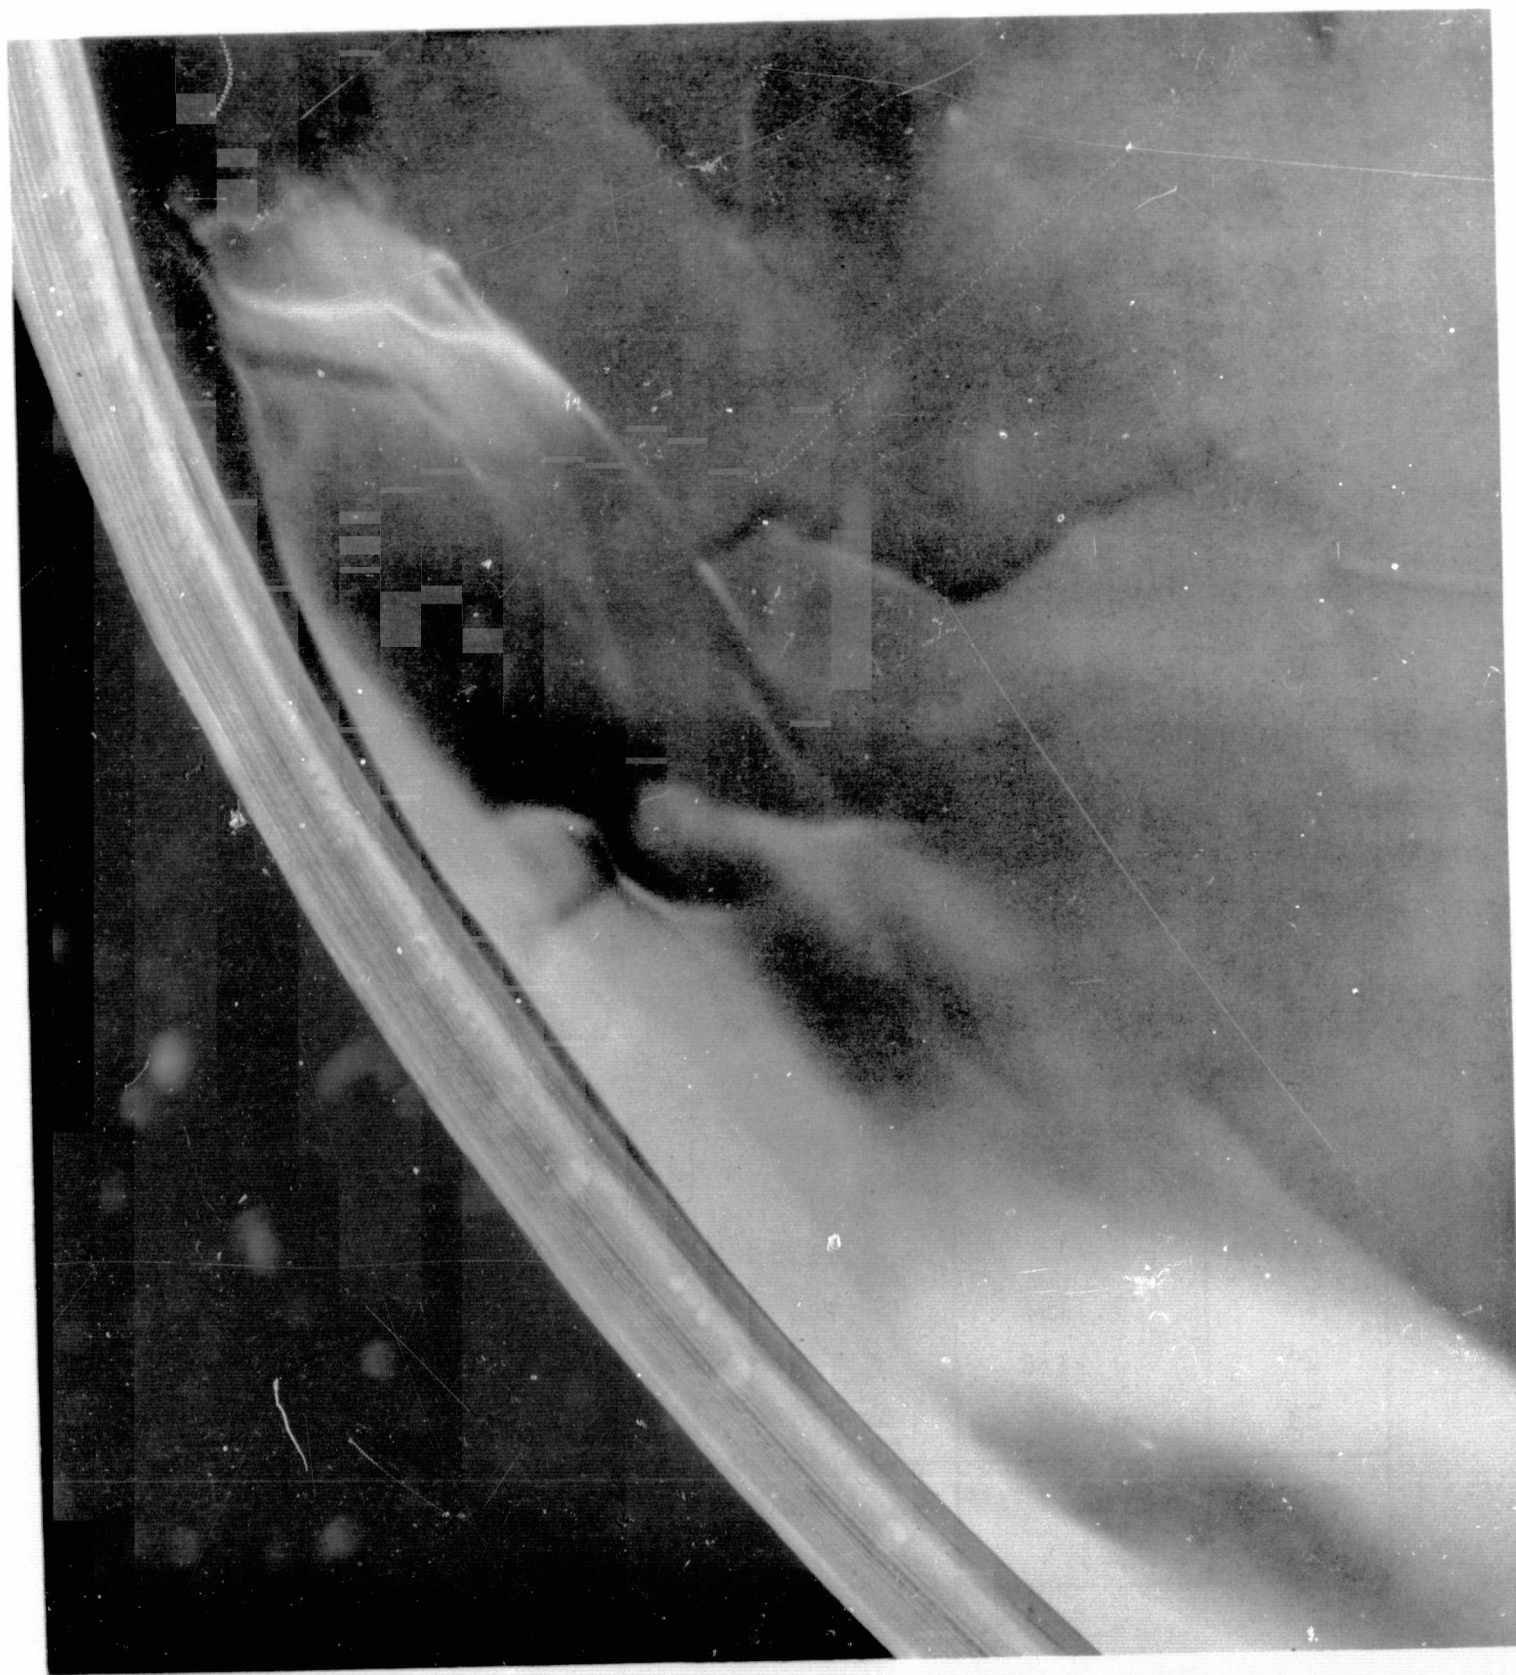
Fig. V-16 Diaphragm Seal

Diaphragms - During the fabrication of the diaphragms some difficulty was experienced in obtaining a heat fusion of the membrane to the flange ring. The ring was coated with codispersion Teflon with a thin coating of FEP applied as the final spray on the bottom of the ring. This was to provide a positive heat seal between the codispersion ring and the laminated membrane. The sealing of the first diaphragm was extremely difficult and the heat sealing operation was repeated several times before a leaktight seal was obtained. Some blistering of the seal area was evident. There was no established criteria for the inspection and acceptance of the heat seal area. As a result, the diaphragms were shipped to Denver so that the heat seal area could be reworked by hand stoning the surfaces for a smoother finish. Table V-2 presents the data before and after rework. The drawing value for the total flange thickness was 0.110 to 0.112 in. The delivered and reworked units were slightly thicker than this value; therefore some unevenness could be accepted and still effect a good seal. On the basis of these results S/N 102 was assigned to the module build and S/N 101 was assigned to the component tank. Figure V-16 is a photograph of the seal area blistering. As explained later this seal provided an effective seal.

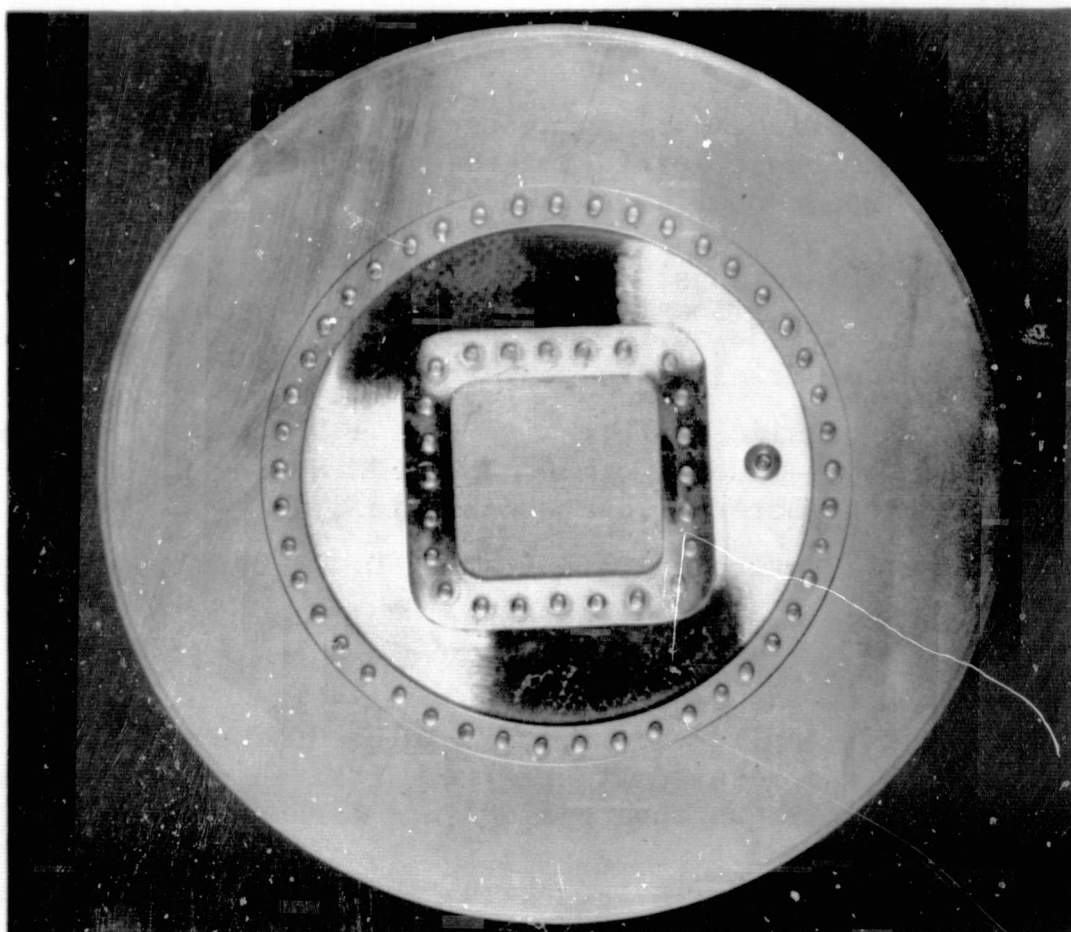
Fig. V-23 Modified Trap Assembly, Top View

The lower half of the fuel tank was modified by adding more weld material at the point of the trap attachment area. This enabled the trap to be elevated slightly with respect to the tank bottom. When the trap was welded into place in the fuel tank a Martin Marietta engineer applied the water glass to the titanium ring area. The water glass was applied after welding to avoid destroying the bond by the thermal effects of the weld operation.

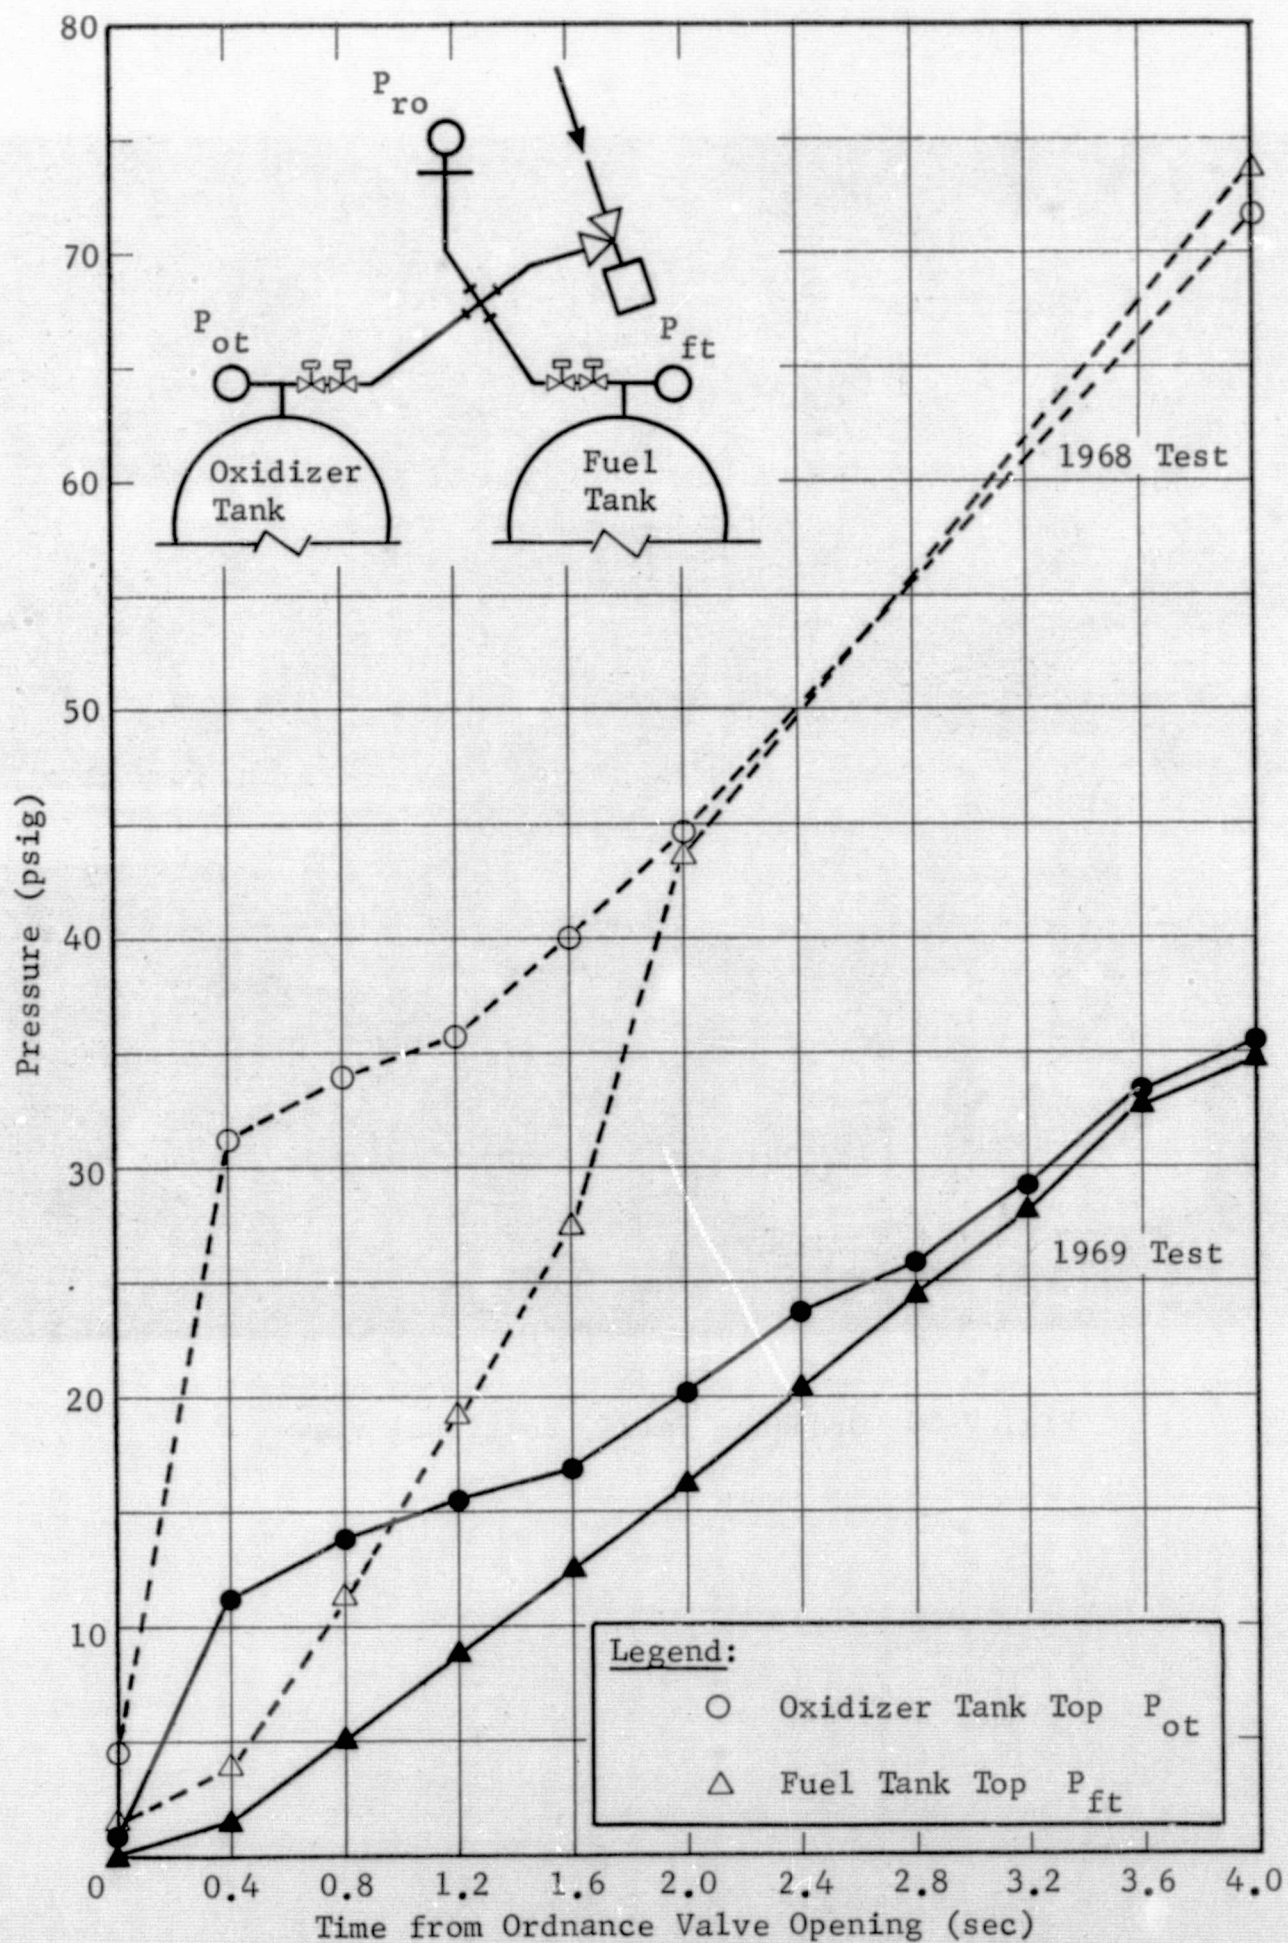
Fig. V-29 Module Pressurization Sequence, Initial Attempt

Investigation and examination of the module revealed the pressurization line just upstream of the ordnance valve, EXV-3, had a sizable hole in it. Figures V-27 and V-28 show a close up of this line and failure.

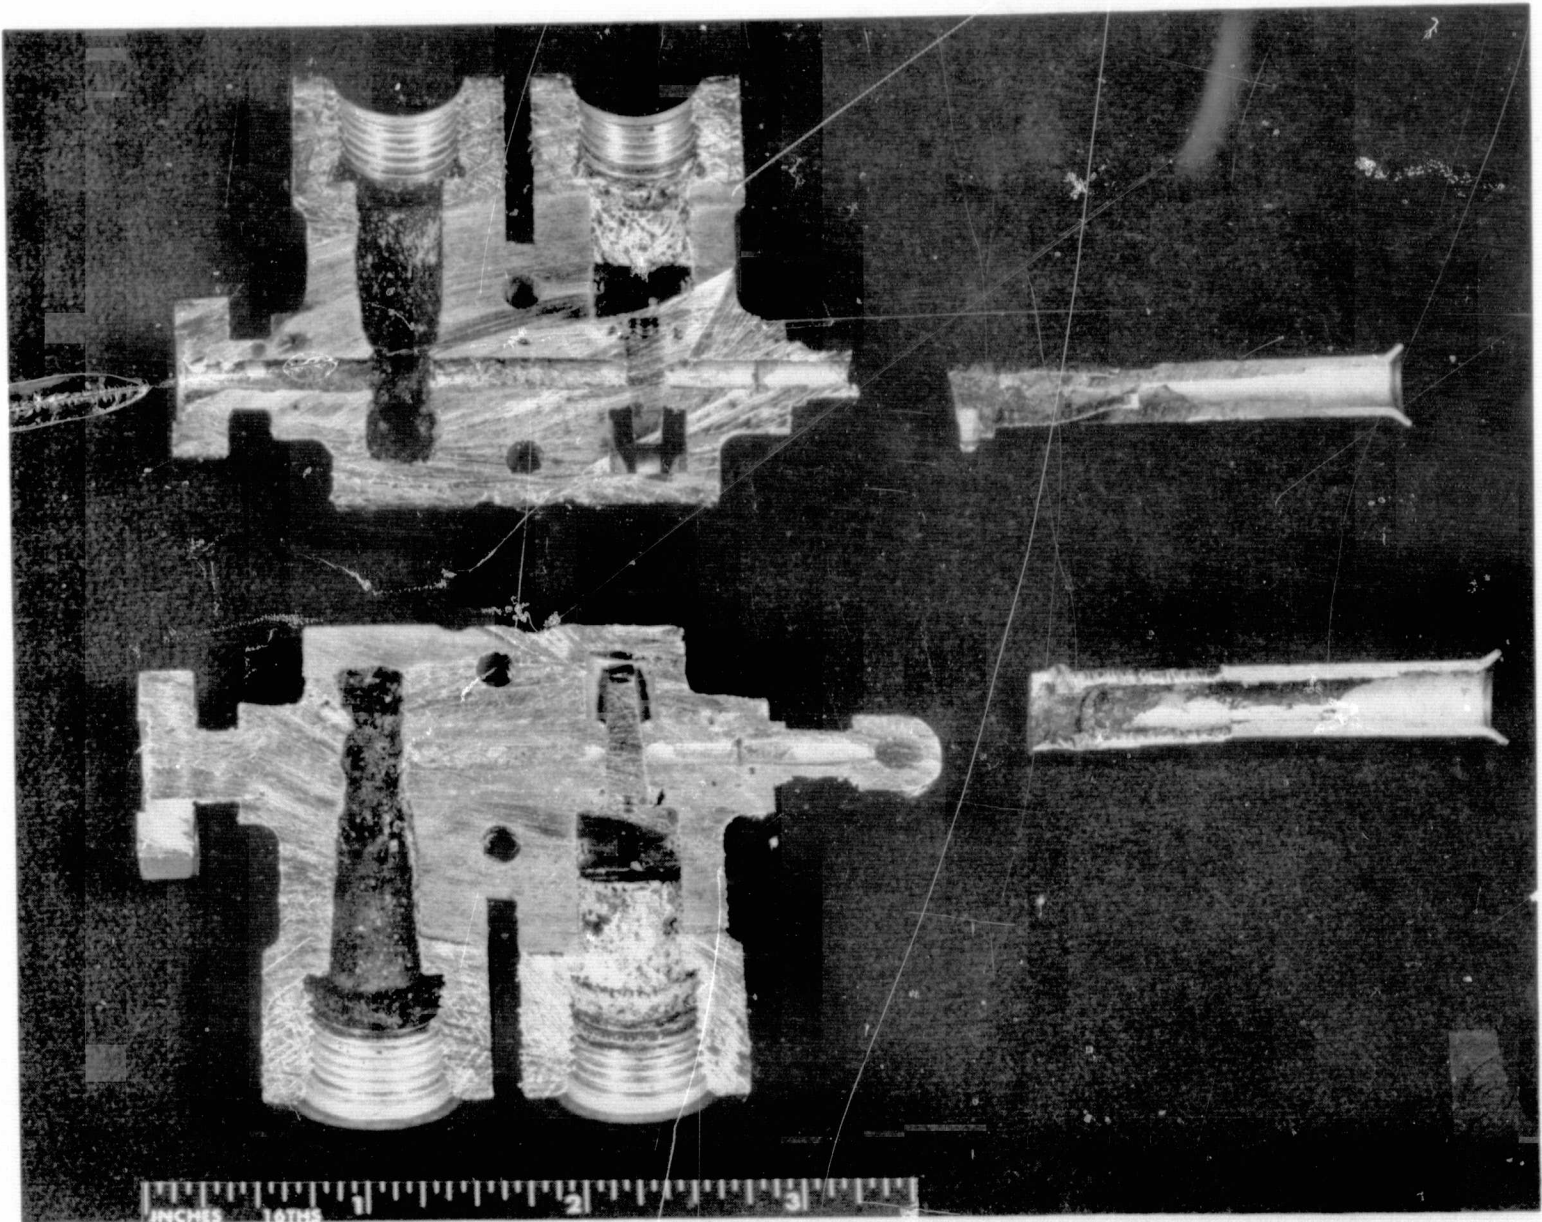
Fig. V-30 Ordnance Valve, Sectional View

- 1) The cause of the aborted firing attempt was the improper assembly of an ordnance valve. This allowed burning combustion products and melted aluminum to enter the system tubing, which led to a tube failure at a bend in the tube;

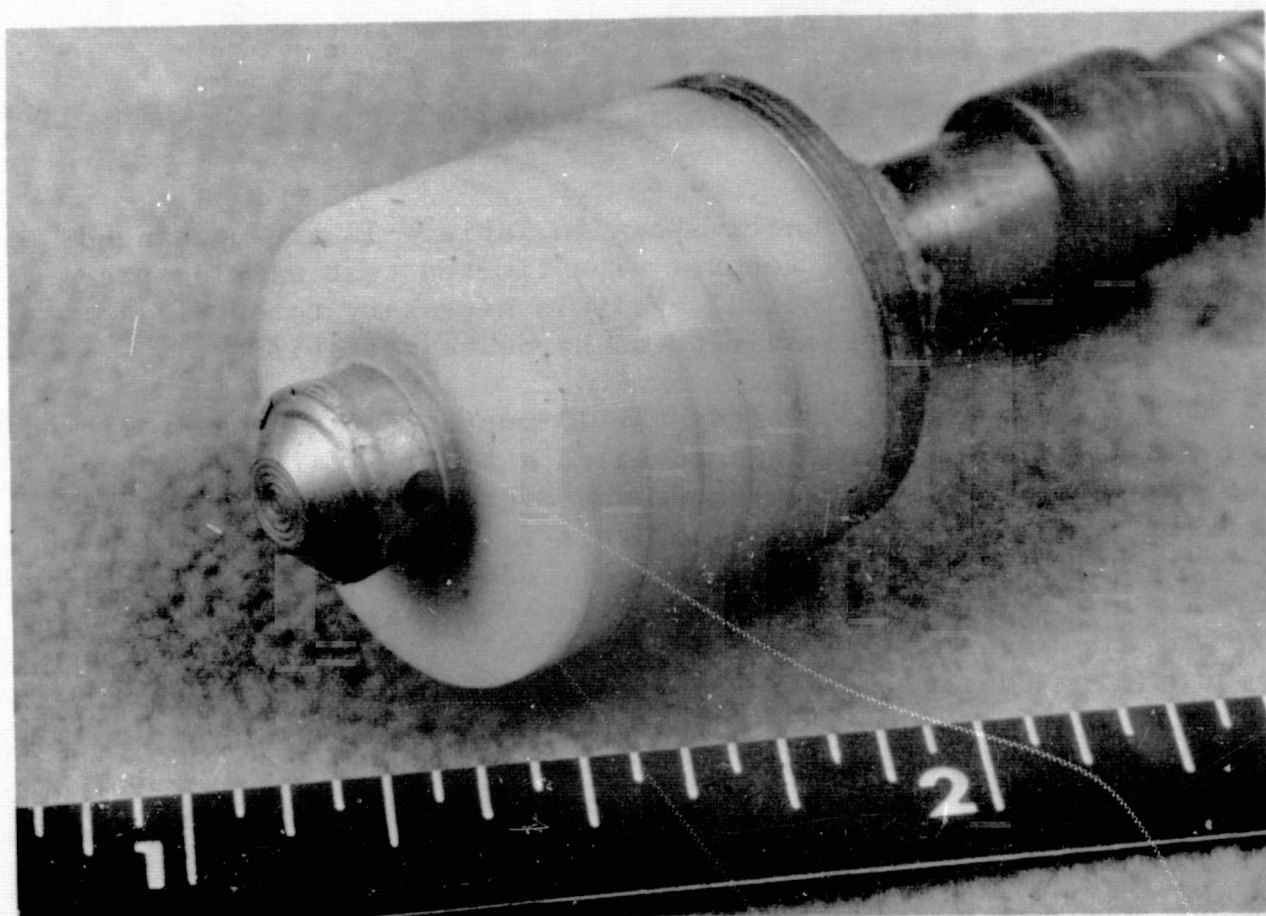
Fig. V-34 Hand Valve Stem

- 4) The hand valves incorporated in the system showed the same degradation as reported in Part I of this report;
- 5) The design of the oxidizer tank diaphragm girth seal has been adequately demonstrated. Teflon permeation remains an important factor in the diaphragm and tank design;
